**Flood Control Project Maintenance
Levee Inspections**

Fall 2018 Levee Maintenance Deficiency Summary Report

San Joaquin River Basin

Reclamation District No. 2101 Blewett

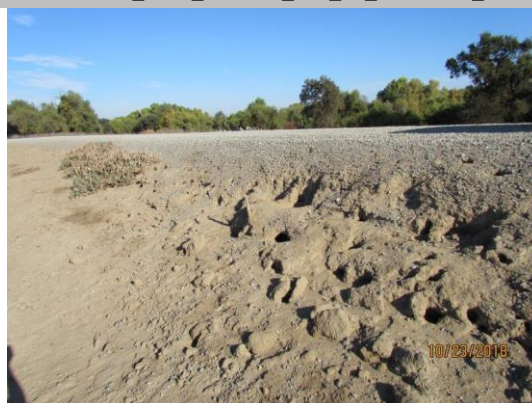
Photo 3 of 3 : FA_2018_RD2101_326_15_20181023_00055.jpg

LM Start	0.10	Rating **	M	Issue No.	15 (cont)
LM End	0.10	Issue Type +	Ma	Location *	LS

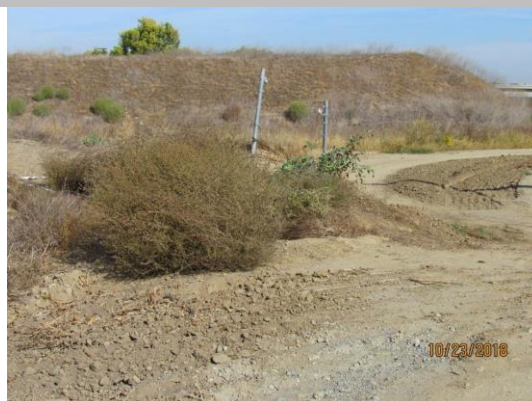
Photo 2 of 2 : FA_2018_RD2101_326_44_20181023_00059.jpg

LM Start	2.85	Rating **	U	Issue No.	44 (cont)	
LM End	2.85	Issue Type +	En	Location *	CR	
Category	Earthen Levee			GPS Latitude/Longitude		
				Start		End
Item	Encroachments			37.640145°	37.640145°	
				-121.230042°	-121.230042°	
DWR ID	DWR_RD2101_01_f_2018_44					
Comment Code						
AT : Agricultural tilling						
Inspector Comment						
Tractor use of levee slope is damaging levee prism. Block use and restore levee cross section
